Airworthiness Directive

Docket No. 89-ANE-21; Amendment 39-6427; AD 90-04-06 R1

TEXTRON LYCOMING Models All Textron Lycoming Four Cylinder Piston Engines **PDF Copy (If Available):**

90-04-06 R1 TEXTRON LYCOMING: Amendment 39-6427 as revised by Amendment 39-6915. Docket No. 89-ANE-21.

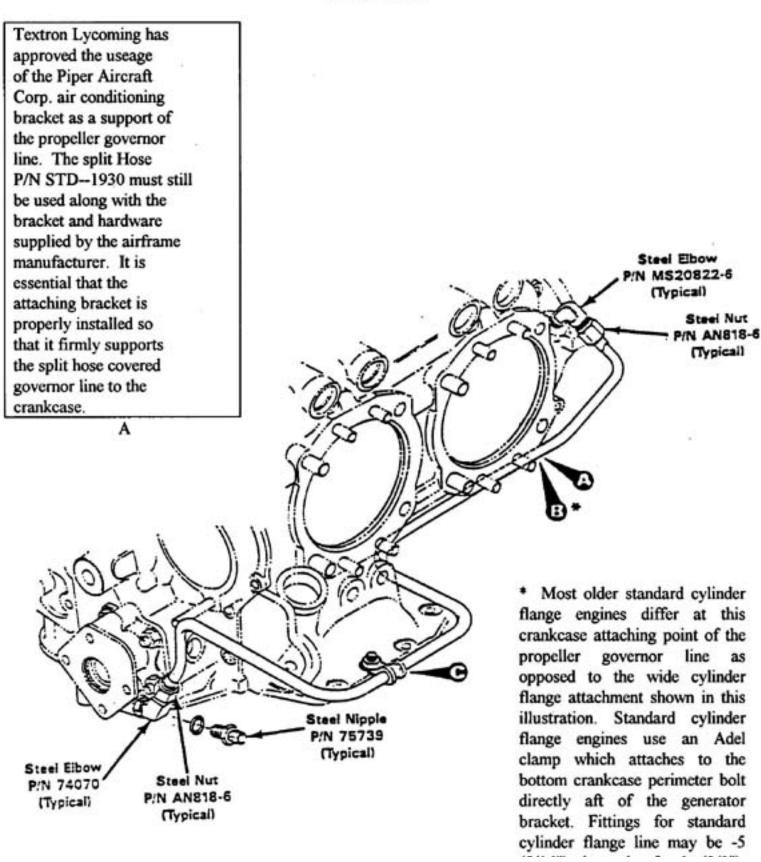
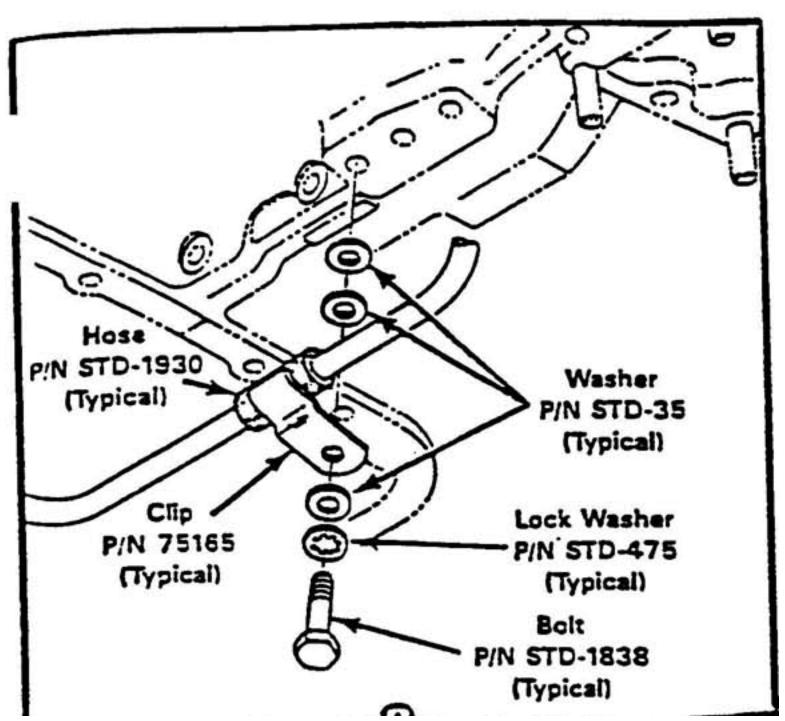
Figure 1. Propeller Governor Line Support PART 1

- (1) Inspect the propeller governor external oil line for abrasions, cracks, and oil leaks along the length of the line and at the end attachment fittings. Inspect to determine that the two cushion type support clamps or clips are properly installed as shown in Figure 1 of Appendix 1 to this AD, and assure that sufficient clearances exist between the oil line and adjacent components.

cylinder flange line may be -5 (5/16") instead of -6 (3/8"). Also, some earlier model propeller governor drives used 1/4" NPT fittings in the prop. governor adapter. If any of these fittings are found, replace with equivalent AN or MS steel fittings.

- (2) If any leaks, chafing, or interference condition exists or if the two support clamps or clips are not properly installed, replace the governor oil line and its attachment end fittings with new parts even though the parts show no visible damage. Refer to Figure 1 in Appendix 1 to this AD, for parts identification, line routing, and location of support clamps or clips. The fittings in the engine case and governor must be replaced if they are damaged or are made of aluminum.

- (b) At the next engine overhaul or anytime the governor oil line is removed for any reason, whichever occurs first, but no later than May 1, 1992, remove any governor oil line assembly having integral aluminum connecting nuts and reinstall an oil line assembly with corresponding steel connecting nuts. Replace any engine case/governor aluminum fittings with corresponding steel fittings as shown in Figure 1 of Appendix 1 to this AD.

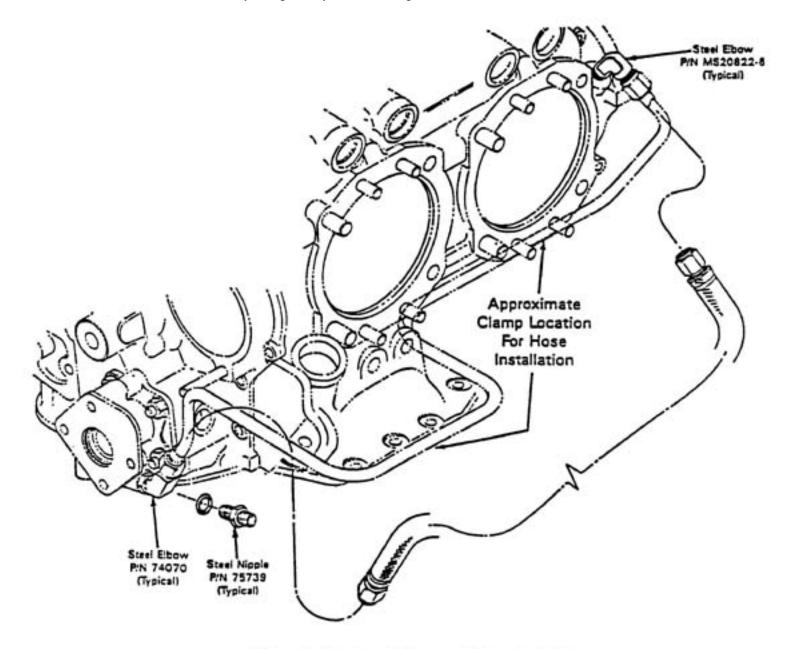
Figure 1. Routing, Fittings and Clamping Detail

If -5 (5/16") fittings have been installed on some standard cylinder flange crankcase model engines, the propeller governor drive fitting and front crankcase fitting must be changed to the appropriate steel fitting to accommodate the new -6 (3/8") line. When re-installing new stainless steel tube assembly, appropriate -5 steel fittings must be re-installed.

IT IS MANDATORY THAT THIS FLEXIBLE HOSE BE REPLACED AT EACH OVERHAUL.

- a. Determine proper hose length as required for your particular installation.
- b. No sharp bends are permissible. Ascertain that no "kinks" exist while routing and clamping hose.
- c. Hose must not be routed near a heat source, such as any portion of the exhaust system.
- d. Hose is to be clamp supported to the engine (not to an airframe component) at a minimum of two locations.
- e. No clamping to cylinder head drain back tubes is allowed.
- f. After installation is complete, ensure that hose is not pinched. Make certain that engine motion during startup and shutdown does not pull or pinch the hose.
