MANDATORY SEL-57-09

WINGS - MODEL 177 CARRY-THRU SPAR ONE-TIME CORROSION INSPECTION

MODEL	SERIAL NUMBERS		
177	17700001 thru 17701164		
177A	17701165 thru 17701370		
177B	17701371 thru 17702752		
177RG	177RG0001 thru 177RG1366		
F177RG	F177RG0001 thru F177RG0177

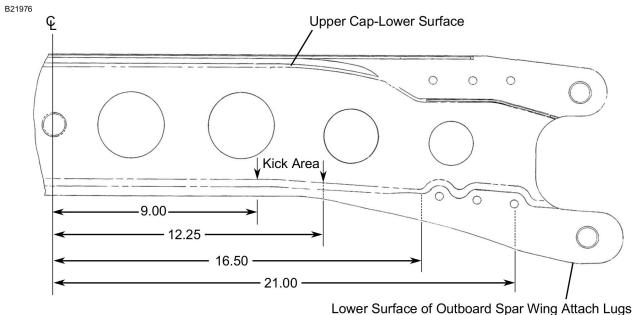
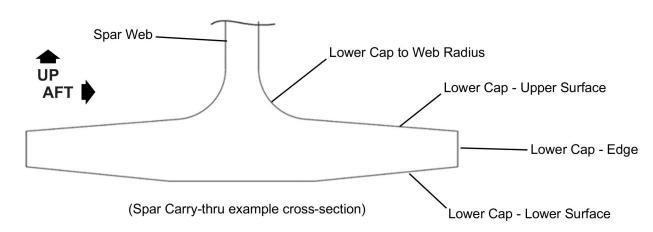
SPAR DIMENSIONS

NOTE: The detailed visual inspection should pay particular attention to locations where air ducts, support wires, and upholstery pads contact the lower spar structure as well as lower spar cap lower surface "Kick Area" between BL 9.0 and BL 12.25. (Refer to the figure titled Spar Dimensions after Table 1.)

Carry-thru Spar Feature	Spar Buttock Line (BL) (in)	Blend Limit (in)	Description
	Lower Cap - Lower	Center Line to 9.0	0.030	Spar Constant Cross Section
1		9.0 to 12.25	0.030	Lower Cap Kick Radius
Surface (1)	12.25 to 21.0	0.030	Outboard of Lower Cap Kick Radius	
2	Lower Cap - Upper Surface (1)	Center Line to 16.5	0.030	Spar Constant Cross-Section thru Cap Kick

3	Lower Cap - Edge (1)	Center Line to 16.5	0.100	Forward or Aft facing cap edges
4	Lower Cap to Web Radius (1)	Center Line to 16.5	0.030 (2)	Forward or Aft facing web radii
5	Spar Web (1)	Center Line to 16.5	0.050 (2)	Includes areas common to web holes

- (1) Limits can't be combined at the same Buttock Line location without contacting Textron Aviation. Example: Web blend and a lower spar cap blend cannot be combined at same Buttock Line location without contacting Textron Aviation.
- (2) The carry-thru spar must be replaced if the blend limit is exceeded in this area.

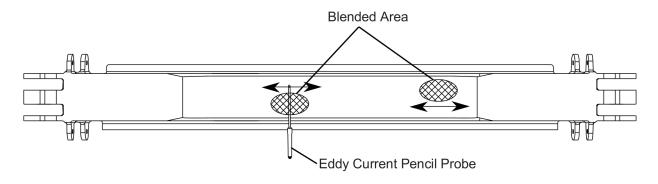
VIEW A-AView Looking Up at Lower Surface of the Carry-Thru

Eddy current inspection will cover the lower service of the carry-thru spar where corrosion was blended and extend 1 Inch beyond the blended area. This inspection technique also applies to the Kick area.

- D. If no corrosion is found on the carry-thru spar, go to Step 8.
- 7. (Refer to Figure 1, View A-A.) (If corrosion was found and blended.) Do an eddy current inspection of the blended area as follows: (Refer to 2A-13-01, Nondestructive Inspection Methods and Requirements in the appropriate Model Service or Maintenance Manual.)

- D. Eddy current scan the blended surface with an 0.125 Inch diameter surface pencil probe at 200 kHz.
 - Scan direction must be with an inboard to outboard direction.

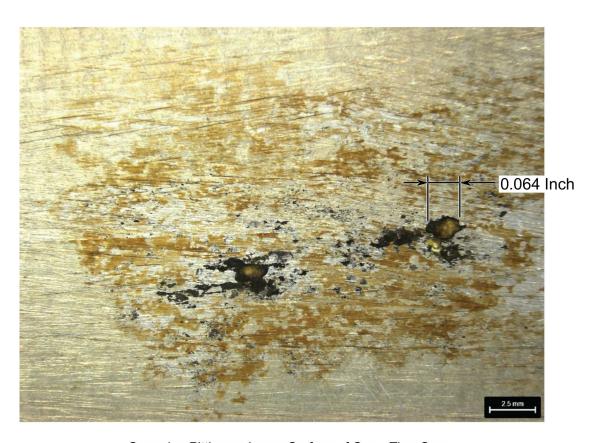
Figure 1. CARRY-THRU SPAR INSPECTION (Sheet 3)

Corrosion Pitting on Lower Surface of Carry-Thru Spar

- (1) Use 180 grit or finer aluminum oxide abrasive paper, cloth or pads to carefully remove corrosion and blend that area locally around the affected region.
- (2) Make sure to only remove the minimum material necessary to blend the corroded surface with the surrounding surface.
- (3) Maintain a minimum of 20:1 blend to depth ratio.
- (4) Leave no sharp edges after blending.
- (5) Finish with a 320 grit or finer grained aluminum oxide sandpaper to 63 micro RA or smoother.

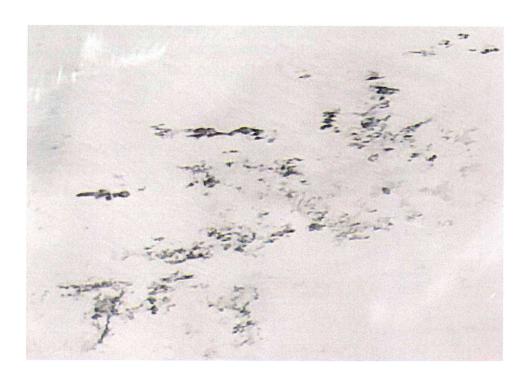
Figure 1. CARRY-THRU SPAR INSPECTION (Sheet 4)

Stress Corrosion Cracking on Spar Cap

- A. (Refer to Figure 1, Sheets 4 and 5.) If stress corrosion cracking or exfoliation corrosion (flaking) of the spar is found, contact Textron Aviation Team Structures for evaluation. (Refer to the Carry-Thru Spar Inspection Report for contact information.)
- B. If corrosion is found on the carry-thru spar, the area can be reworked as follows:

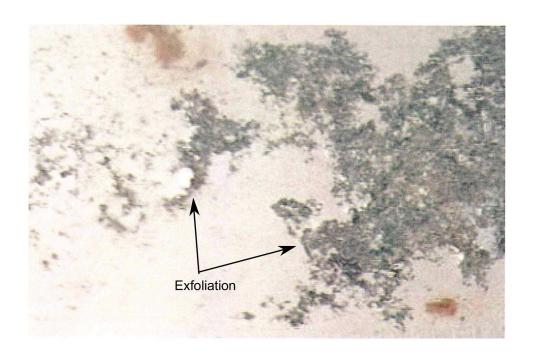
Figure 1. CARRY-THRU SPAR INSPECTION (Sheet 5)

Exfoliation Corrosion on Spar Cap
