single-engine SERVICE LETTER

SE71-32

SUBJECT: ALTERNATE AIR DOOR RELOCATION

1971 Model Cardinal RG Serials 177RG0001 thru 177RG0175
(except as noted on Page 2)
F177RG0001 thru F177RG0030

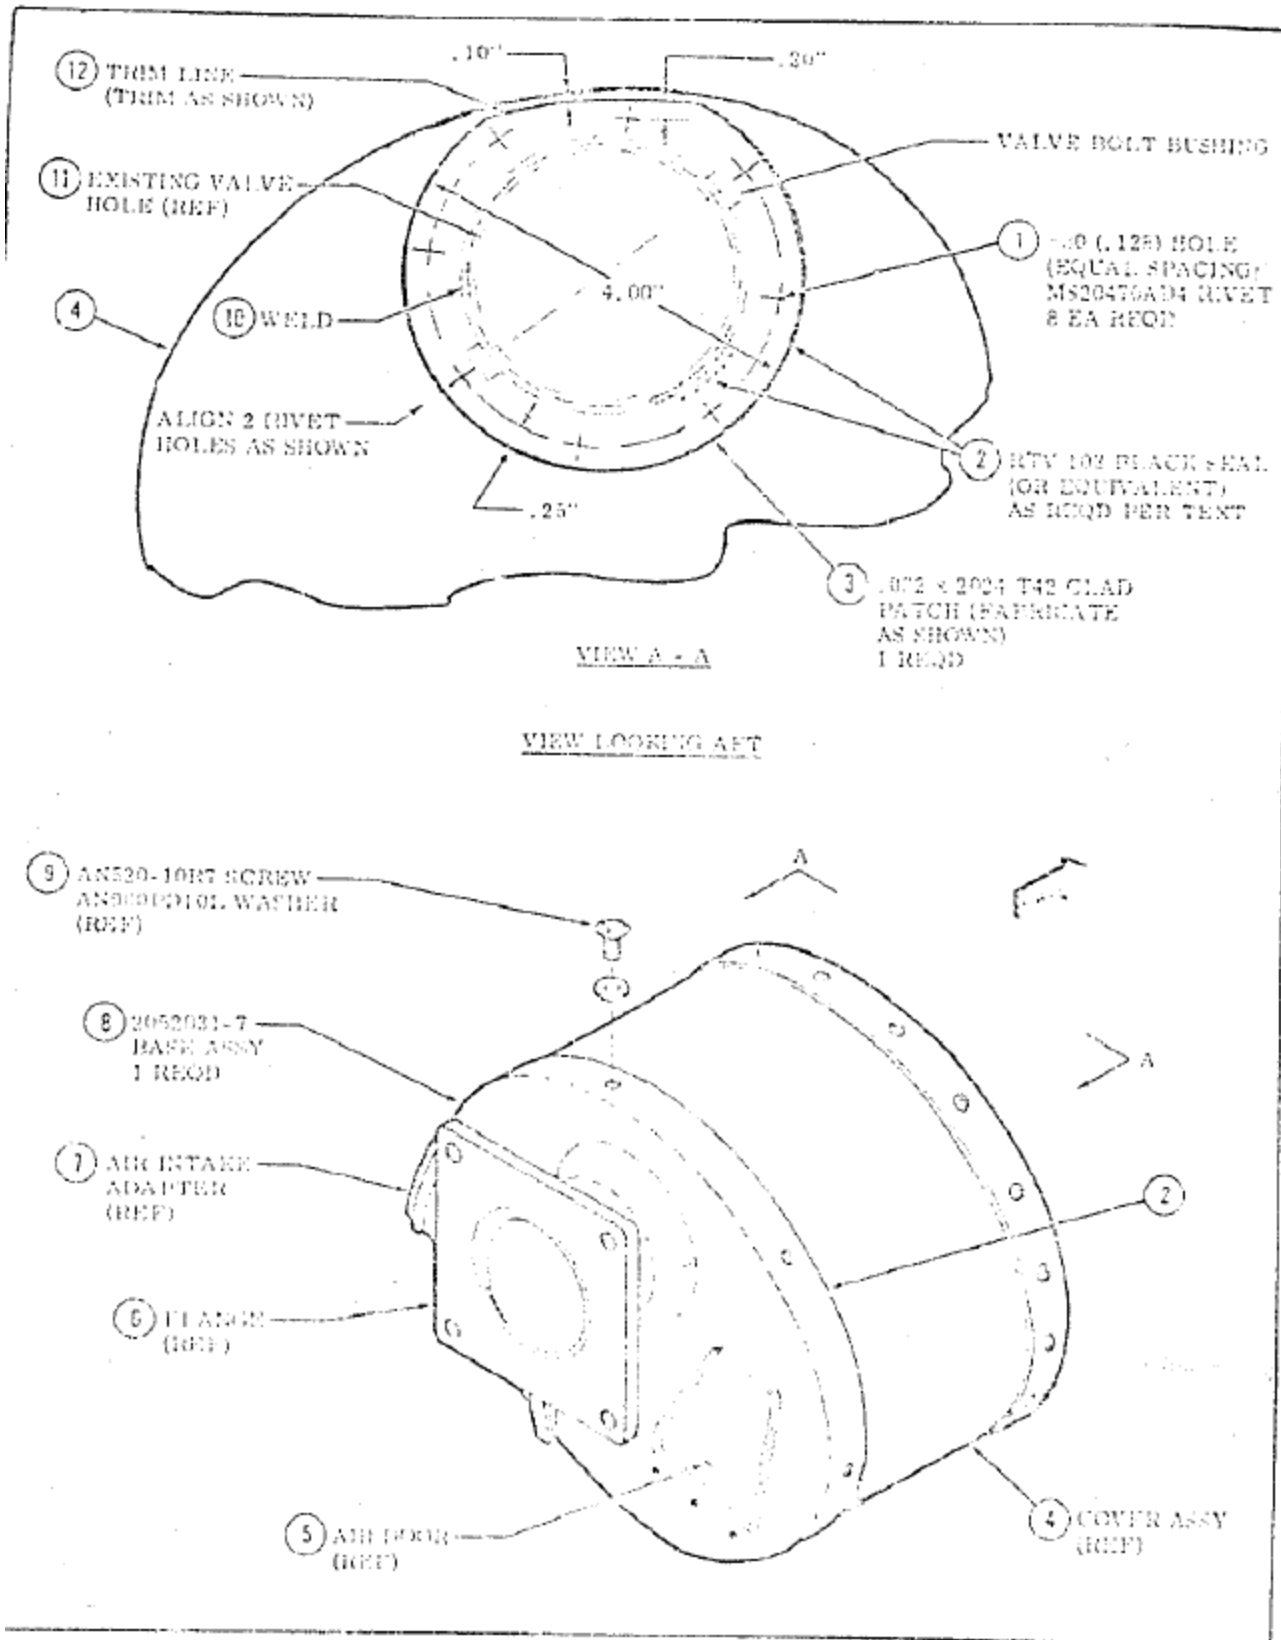
Figure 1. Piston Chamber Modification

Inspect plenum chamber thoroughly for cracks. If cracks are evident in cover (4), replace complete plenum chamber rather than modify.

- b. (Refer to figure 1.) Plenum Chamber Modification.
- (1) Remove and retain 6 screws and washers (9).
 - (2) Separate existing base from cover (4) and discard base.
 - (3) Remove and discard all existing air valve parts from cover (4).
 - (4) Fabricate patch (3) in accordance with material specifications and dimensions shown and as follows:

- (a) Lay out sheet and cut 4.00 inch diameter patch (3).
- (b) Mark and drill holes (1).
- (c) Using patch as a guide drill holes (1) in cover (4).
- (d) Mark and trim along line (12).
- (5) Apply small bead of seal (2) around hole (11) between weld (10) and holes (1) as shown.
- (6) Install patch (3) and secure with rivets (1).
- (7) Apply fillet of seal (2) to outer edge of patch (3).

- (8) Install new base (8) on cover (4) and secure with retained screws and washers (9).
 - (9) Apply fillet of seal (2) to outer edge of base (8).
- c. Plenum Chamber Installation.
- (1) Install plenum chamber in original position, replacing gasket, if damaged, and secure with retained attaching hardware.
 - (2) Install safety wire to attaching hardware.
 - (3) Install hose from air filter to adapter (7).
 - (4) Replace cowl and nose cap on aircraft.
