single-engine SERVICE LETTER

SE70-32

A MANDATORY INSPECTION AND MODIFICATION OF 177/CARDINAL STABILATOR ATTACHMENT IS IMMEDIATELY REQUIRED BECAUSE OF CRACKING OF ATTACHMENT ANGLES IN SOME HIGH TIME 177/CARDINAL AIRCRAFT.

Title INSPECTION AND REINFORCEMENT OF
STABILATOR ATTACH BRACKETS

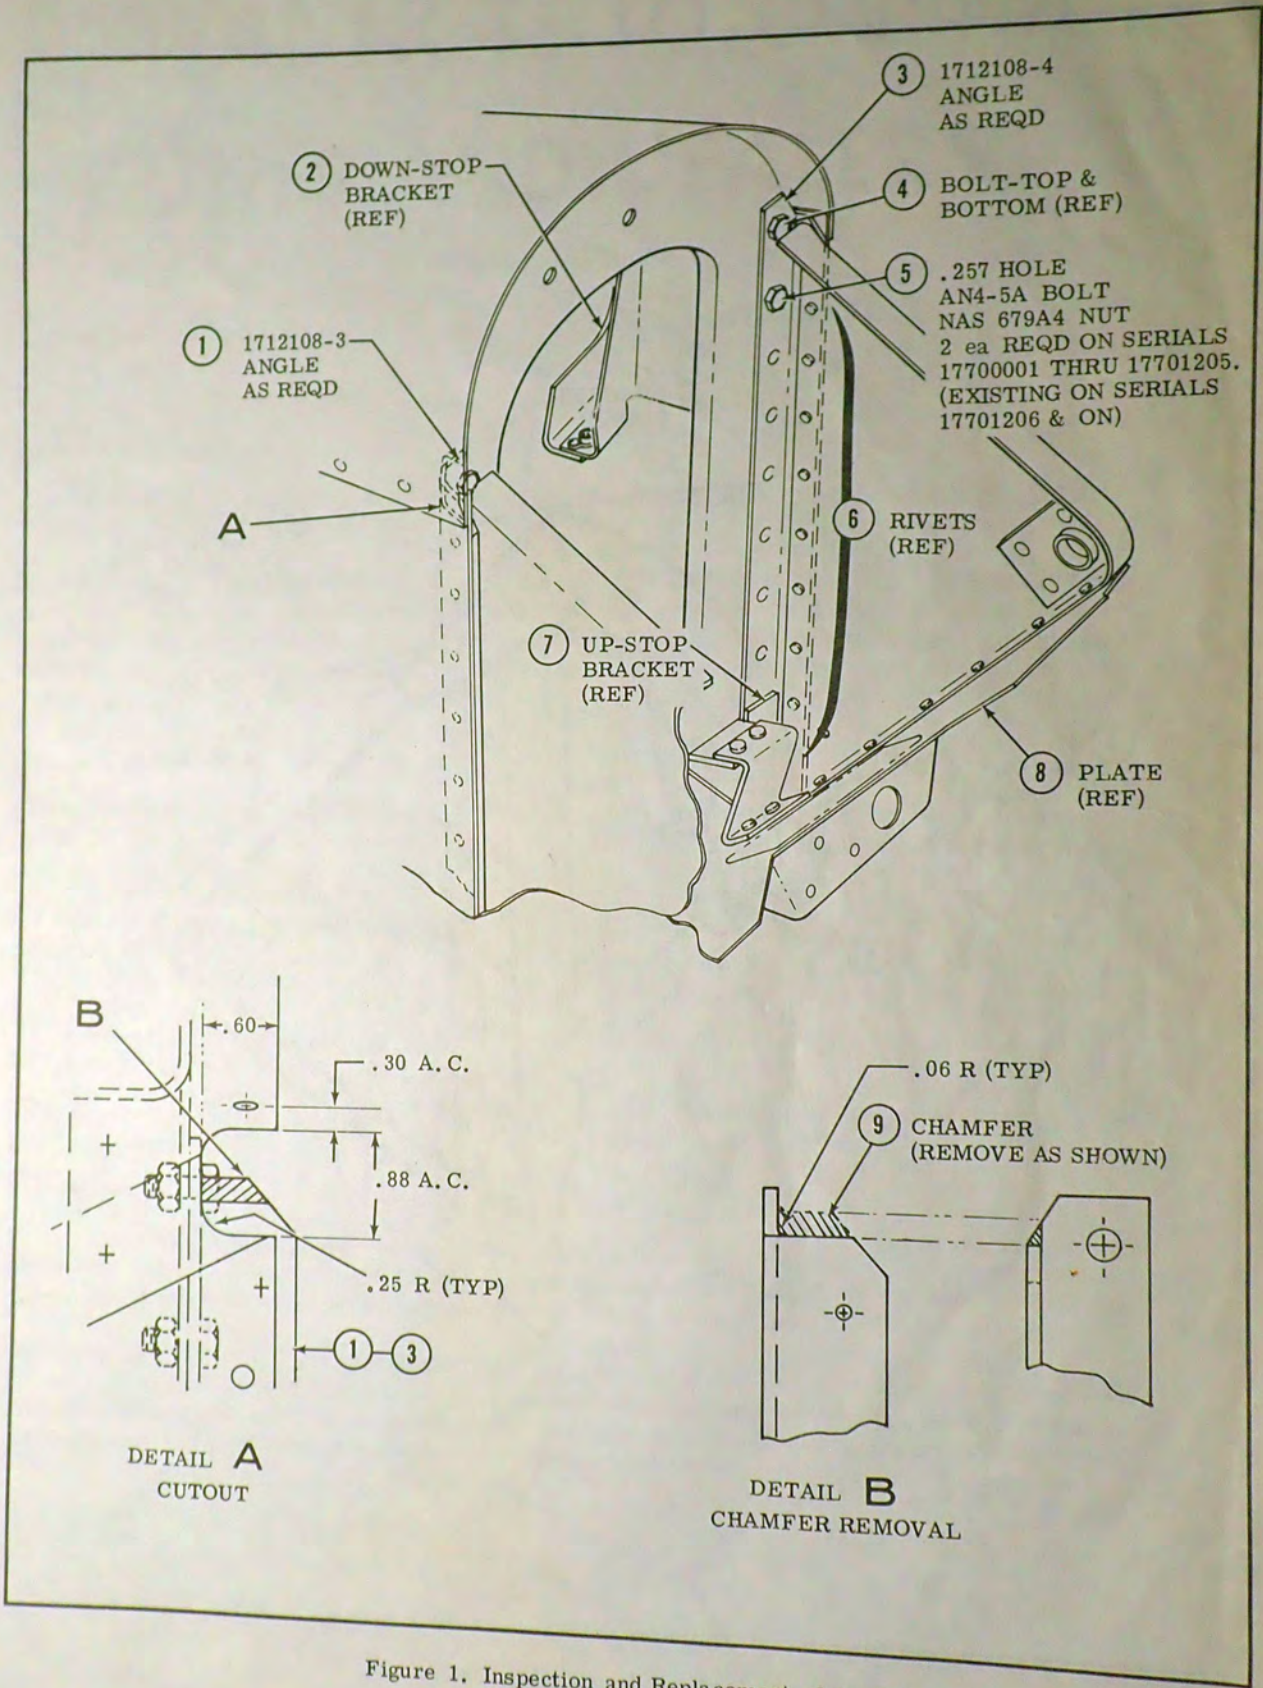
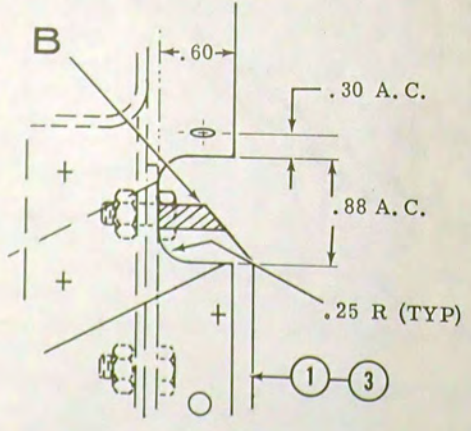
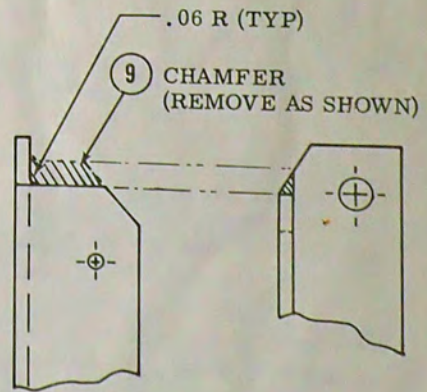
Figure 1. Inspection and Replacement of Angles

Before further flight, conduct a careful visual inspection of the bracket attachment angles shown in Figure 1 of the attached Service Kit (Items 1 and 3). Pay particular attention to the area around the heads of the top attach bolts (Items 4 and 5).

- ① 1712108-3 ANGLE AS REQD
- ② DOWN-STOP BRACKET (REF)
- ③ 1712108-4 ANGLE AS REQD
- ④ BOLT-TOP & BOTTOM (REF)
- ⑤ .257 HOLE AN4-5A BOLT NAS 679A4 NUT 2 ea REQD ON SERIALS 17700001 THRU 17701205. (EXISTING ON SERIALS 17701206 & ON)
- ⑥ RIVETS (REF)
- ⑦ UP-STOP BRACKET (REF)
- ⑧ PLATE (REF)

- A. Any attach angles found cracked must be immediately replaced and SK177-11 installed before returning the aircraft to service.
- B. Within the next 25 hours of operation, on all aircraft, accomplish the special inspection detailed in SK177-11 and install the reinforcement brackets as shown.

- (1) Remove stinger and side plates.
- (2) (Refer to figure 1.) To allow inspection access to angles (1) & (3) cut out skin as shown in detail A, on both sides of tailcone.
- (3) Remove chamfer (9) from each angle (1) & (3) as shown in detail B.

- (4) Apply dye check to each reworked area.

If cracks are still present in angles, each angle must be replaced.
Proceed to step b.
