MANDATORY SEL-57-09

WINGS - MODEL 177 CARRY-THRU SPAR ONE-TIME CORROSION INSPECTION

MODEL	SERIAL NUMBERS		
177	17700001 thru 17701164		
177A	17701165 thru 17701370		
177B	17701371 thru 17702752		
177RG	177RG0001 thru 177RG1366		
F177RG	F177RG0001 thru F177RG0177

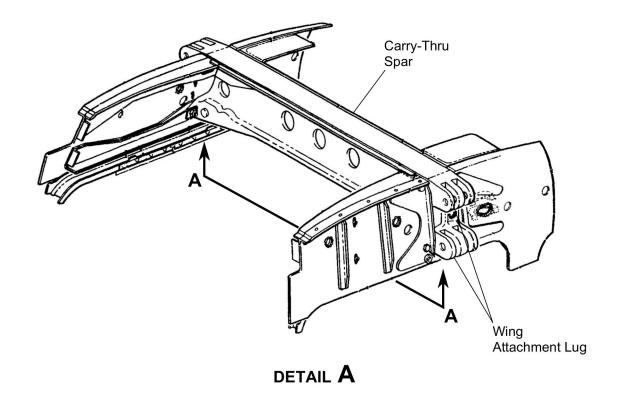
Figure 1. CARRY-THRU SPAR INSPECTION (Sheet 1)

- 5. Clean grime or debris from all interior surfaces of the carry-thru spar with special emphasis on lower cap surface.
- 6. (Refer to Figure 1, Sheets 1-5.) Do a detailed visual inspection of the carry-thru spar with a 10X magnification lens looking for corrosion, nicks, gouges, drill starts, or hardware damage and must include:
